File name: X23-575_867_603____GEO_EN__005____RVTO_MARCO_LUNETA__B-GUSS_KW29___170714_SE376_ACC_141020_003.CATPart

ACC REODUCT-ENGINEERING Proximity report

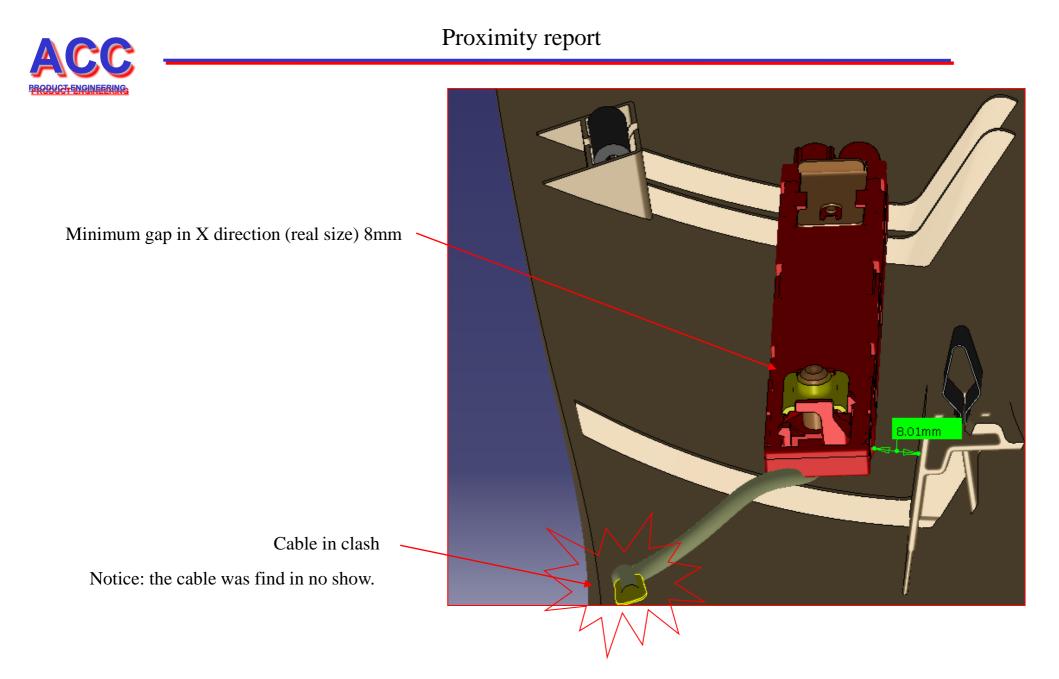
Minimum gap in Z direction (real size) 5 mm (rib high 5mm)

Cable in clash

Notice: the cable was find in no show.

Clash max 0.21mm between upper part EOP and cable (EOP = end of part)

CLERANCE ?

5.047mm

SHOULD WE MAKE A CUTOUT IN ORDER TO AVOID THIS INTERFERENCE?

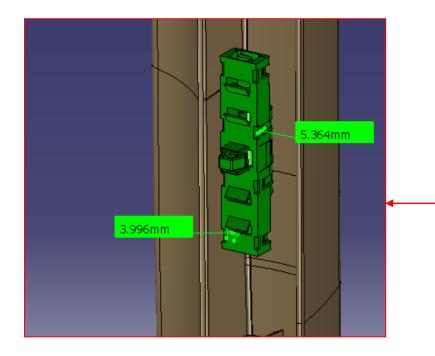
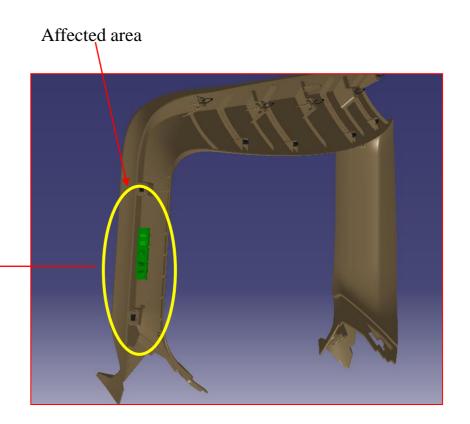
Minimum gap in X direction 4.0 mm against gass canal Minimum gap in Y direction 5.3 mm against B face

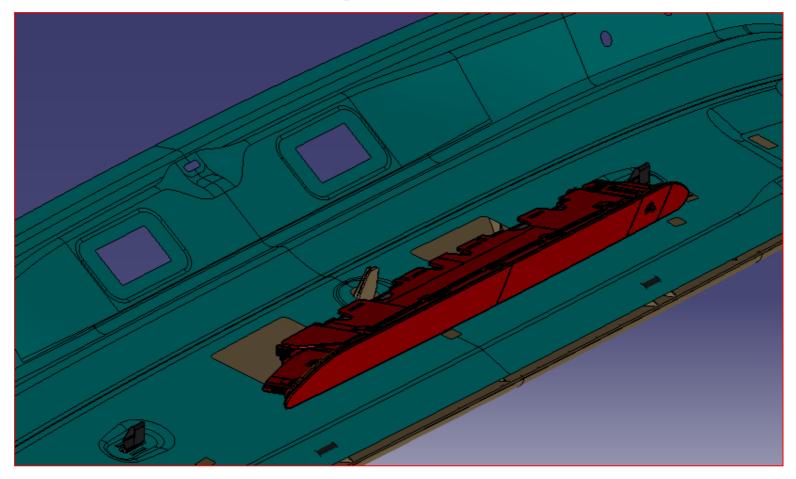
NO CLASH OR PROXIMITY UNDER 10mm

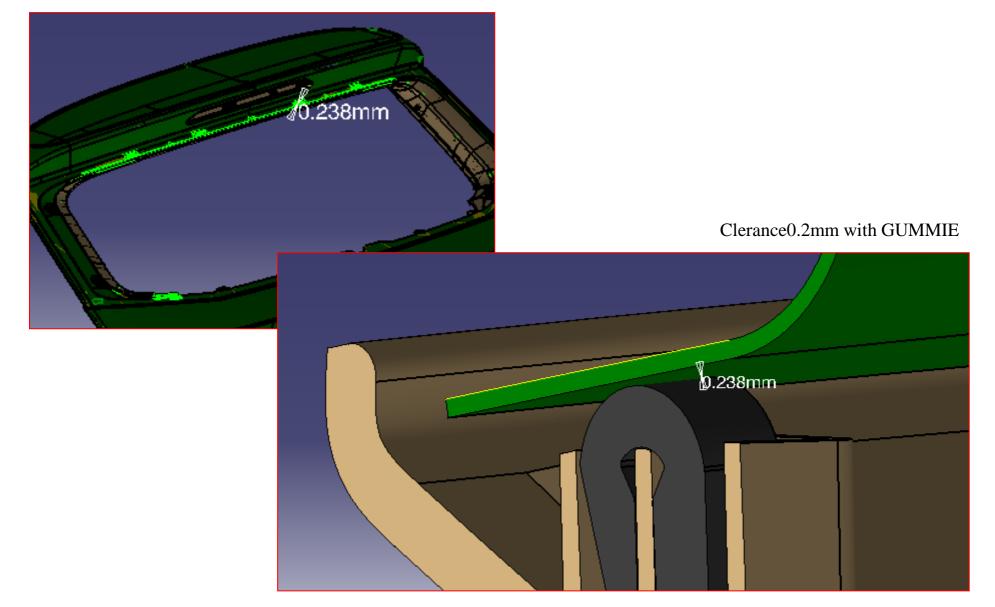
Minimum distance 0.24mm no clash

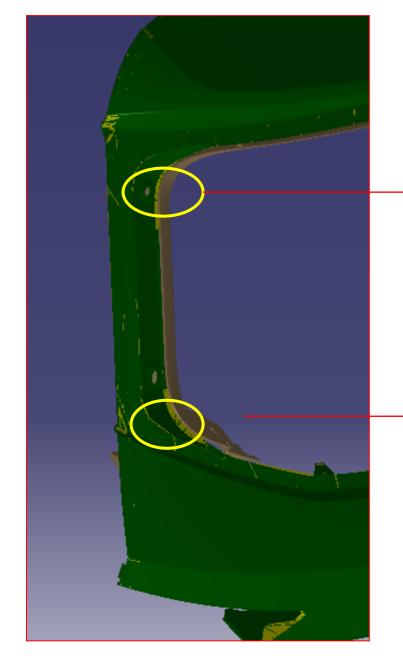
PLEASE SPECIFY IF 0.413 IT COULD BE CONSIDERED

CORRECT, OR, WE SHOULD PASS TO 0.5mm.

Clerance 0.5mm

Clerance 0.4-0.5mm

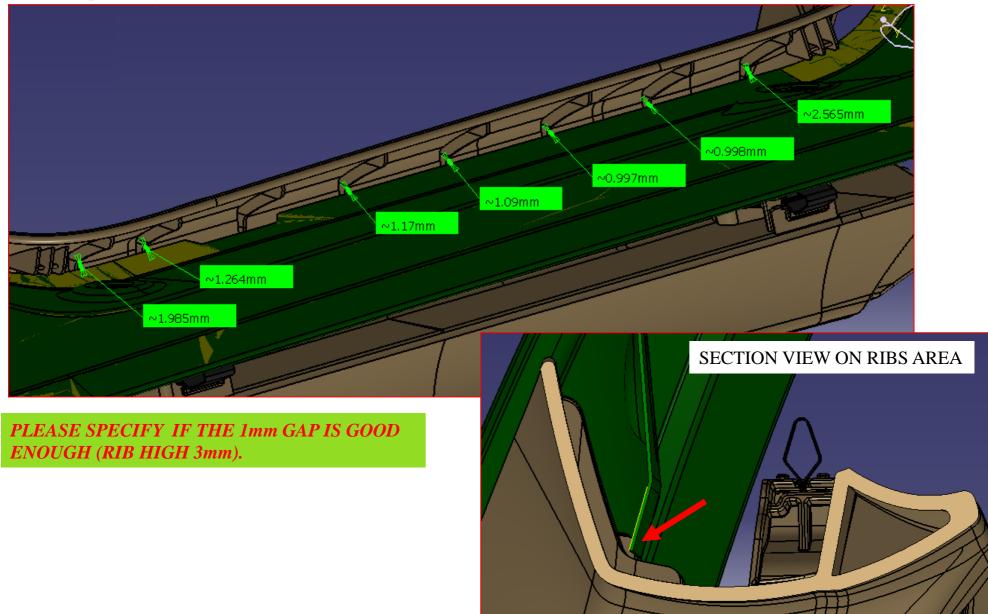
Side ribs proximity 1mm minimum.

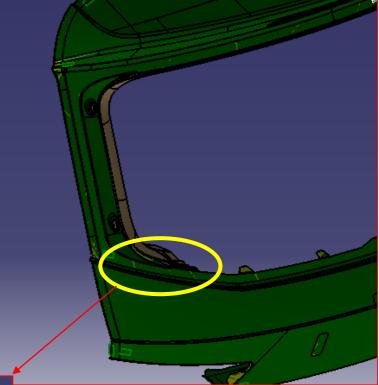
PLEASE SPECIFY IF THE 1.5mm GAP IS GOOD ENOUGH.

GAP 1.5 mm

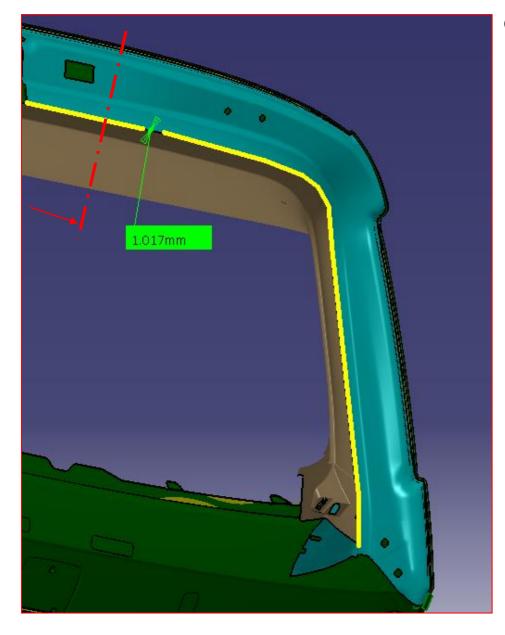
Clerance 1mm with hayon stiffner

It is the Seat definition I will inform them in case they want to update.

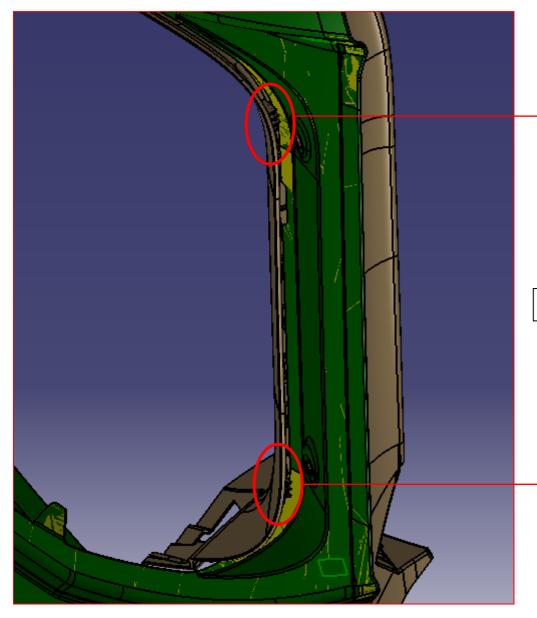
O.k. It will be adjustment area for the tool

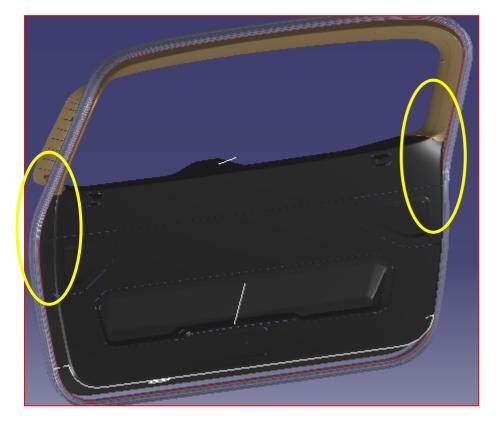
Remark: Possible issue for style surfaces.

Apearence - not constant gap in this area

I will inform Seat in order to get a feedback

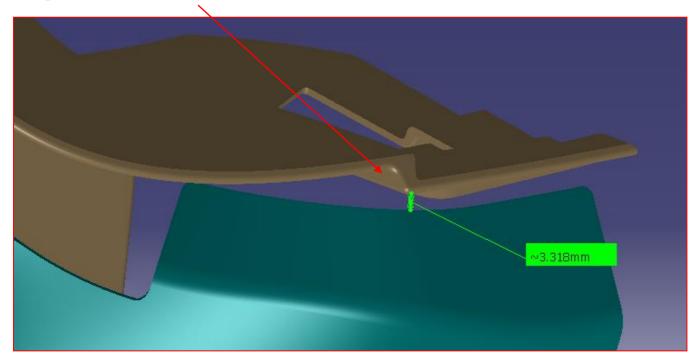
Clerance 4.5mm in X direction

PLEASE SPECIFY IF THE 3.3 mm GAP IS GOOD ENOUGH.

Gap 3.3mm in Z direction.

I will inform Seat in order to get a feedback

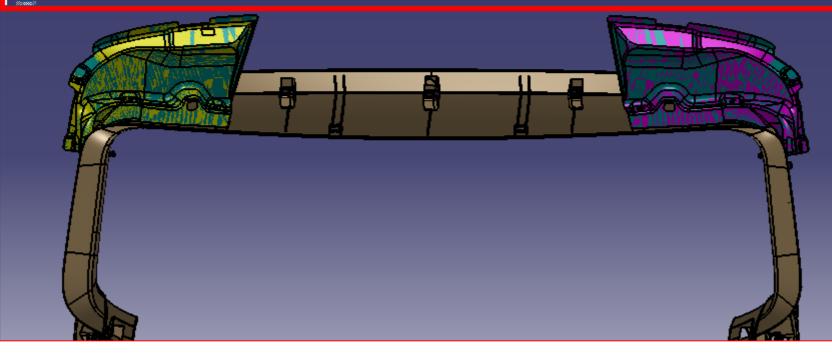
GAP mini 0.5mm on the rib (rib high 5mm) GAP mini 4.5mm with the B surface of the part.

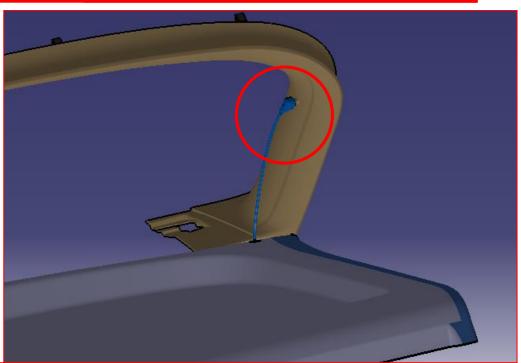
Environement in wrong position

I have already asked for updated environment

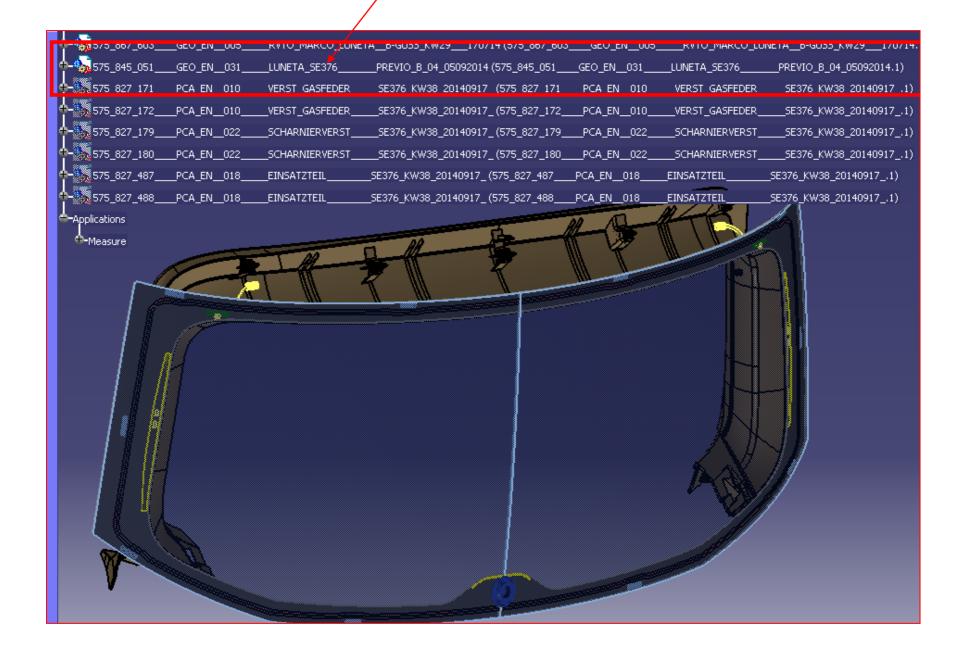
Gap mini 2.4mm on the technical area General gap 2.5mm.

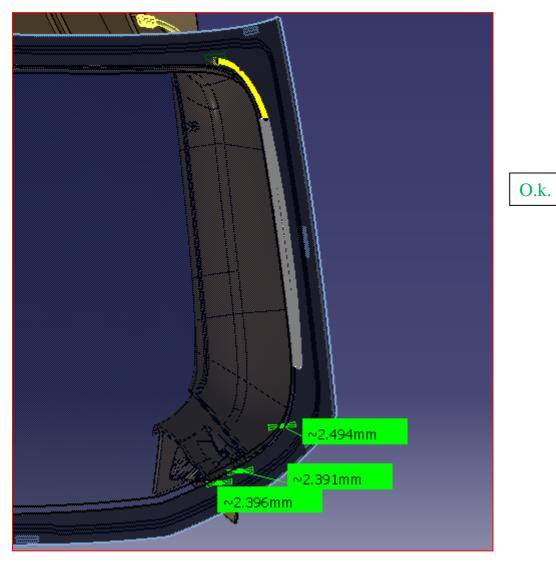
0.2mm colission

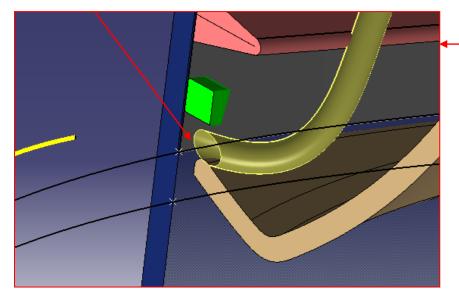
Proximity in Z direction 2mm

I will inform Seat about this issue

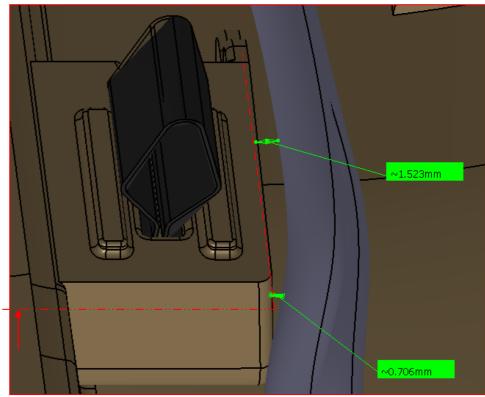
v1.523mm

Should we try to reach the yellow limit?

Please, try to get a minimum of 2mm gap with cords.

Yesterday I got an updated electrical cords from Seat. I will inform Cristian about the folder of this information.

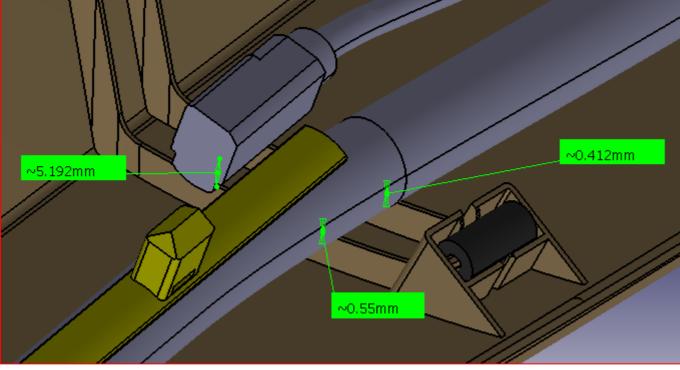
Please specify the correct gap (rib high constant 5mm).

Please, try to get a minimum of 3mm gap between cords and ribs

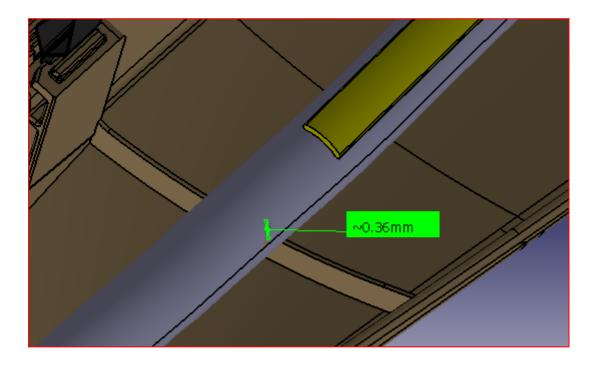
Please specify the correct gap (rib high constant 5mm).

Please, try to get a minimum of 3mm gap between cords and ribs

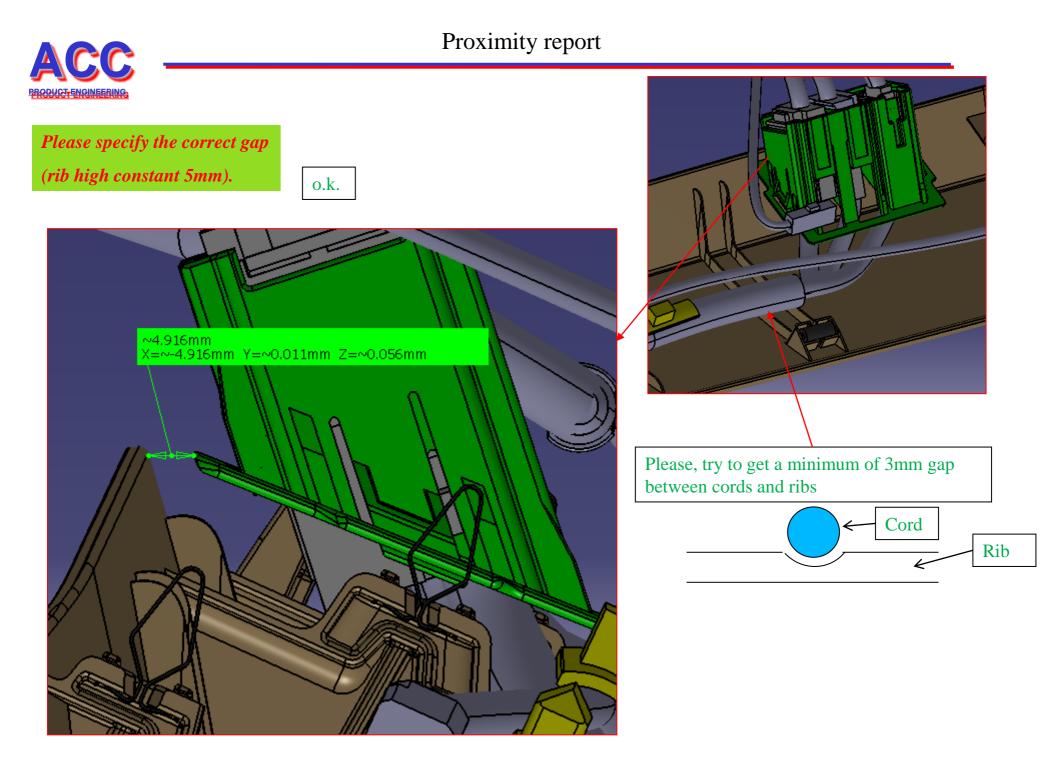
Please specify the correct gap (rib high constant 5mm).
