X23-575\_867\_603\_\_\_\_GEO\_EN\_\_005\_\_\_\_\_RVTO\_MARCO\_LUNETA\_\_B-GUSS\_KW29\_\_\_170714\_SE376\_ACC\_141020\_003.CATPart

Analize made against this part file name.

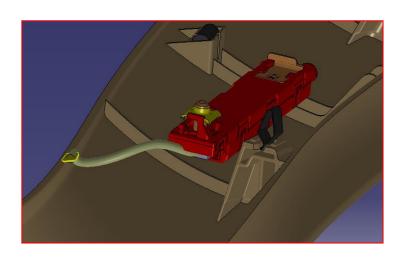
Minimum gap in X direction (real size) 8mm

o.k.

Cable in clash

Notice: the cable was find in no show.

I will inform Seat in case is important

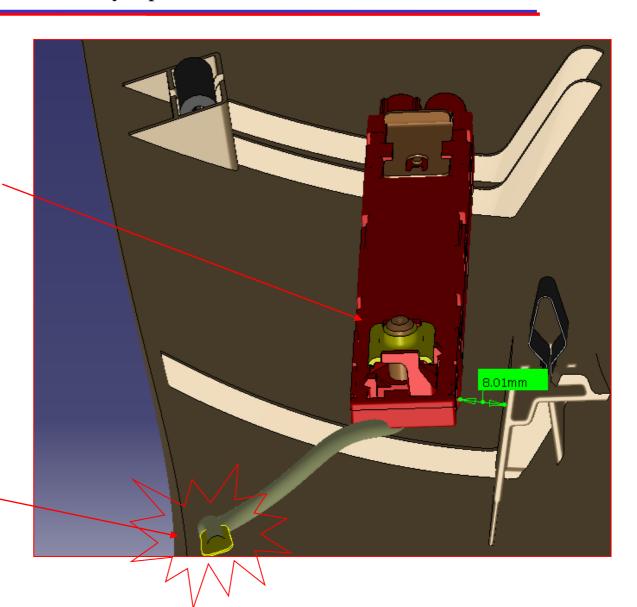
Minimum gap in Z direction (real size)
5 mm (rib high 5mm)

O.k.

Cable in clash

Notice: the cable was find in no show.

Clash max 0.21mm between upper part EOP and cable (EOP = end of part)

I will inform Seat in case is important

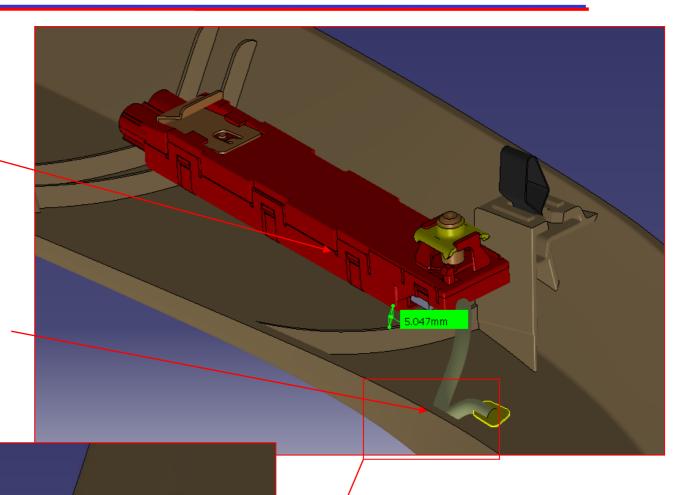
SHOULD WE MAKE A CUTOUT IN ORDER TO AVOID THIS INTERFERENCE?

**CLERANCE**?

No

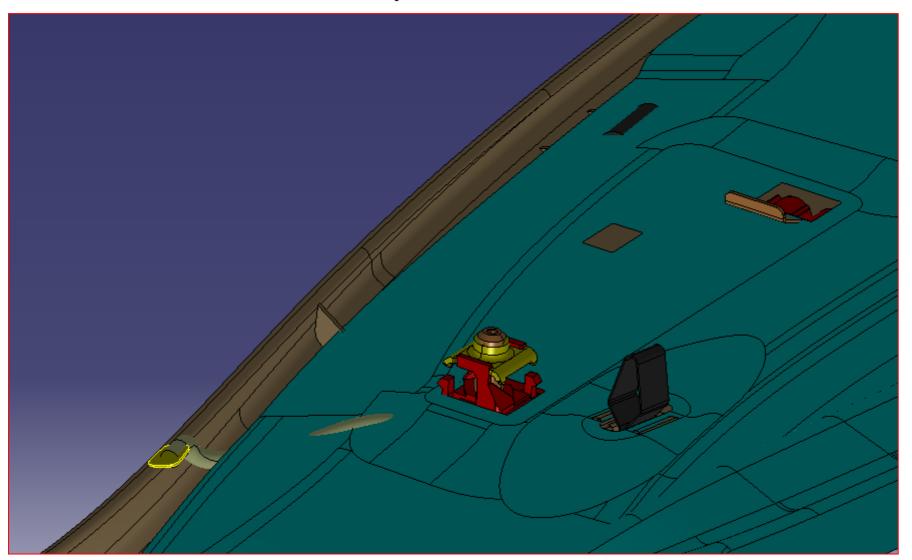
General aspect with BIW in show

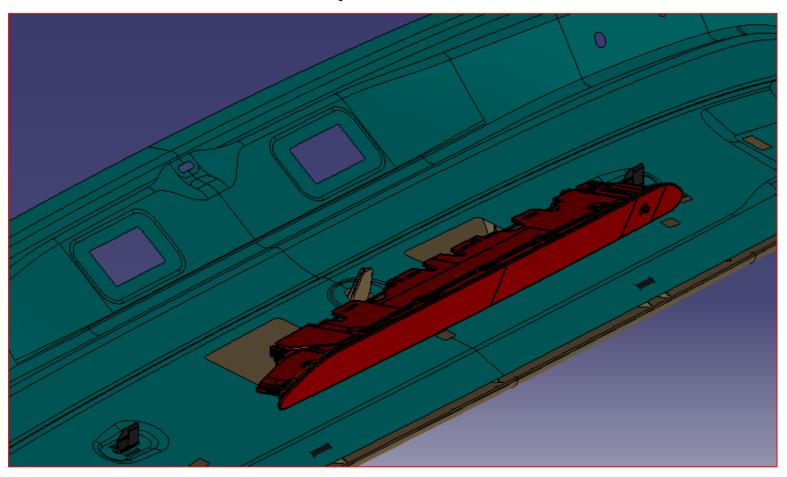
NO CLASH OR PROXIMITY UNDER 10mm

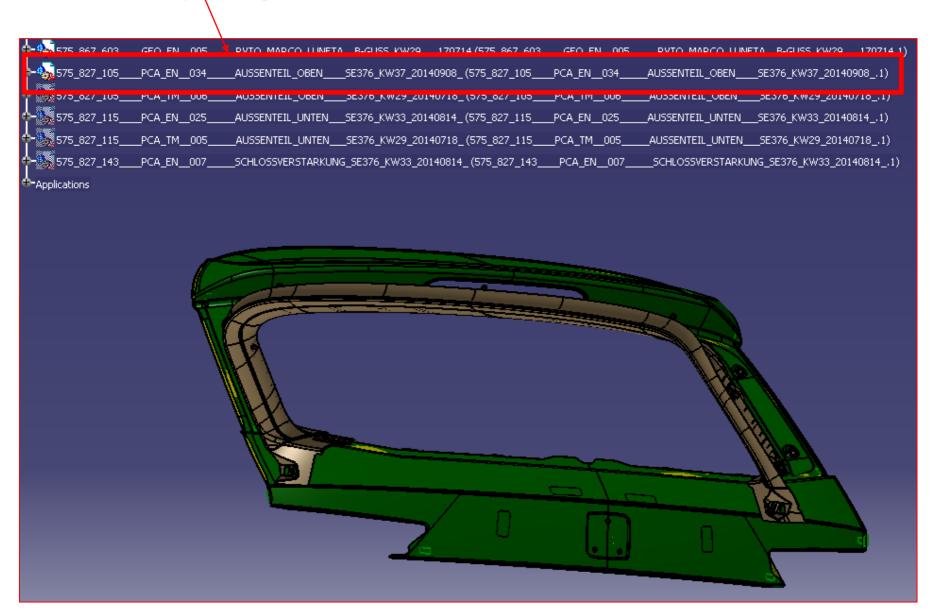
Minimum distance 0.24mm no clash

0.238mm

Clerance0.2mm with GUMMIE

We should have clash as in

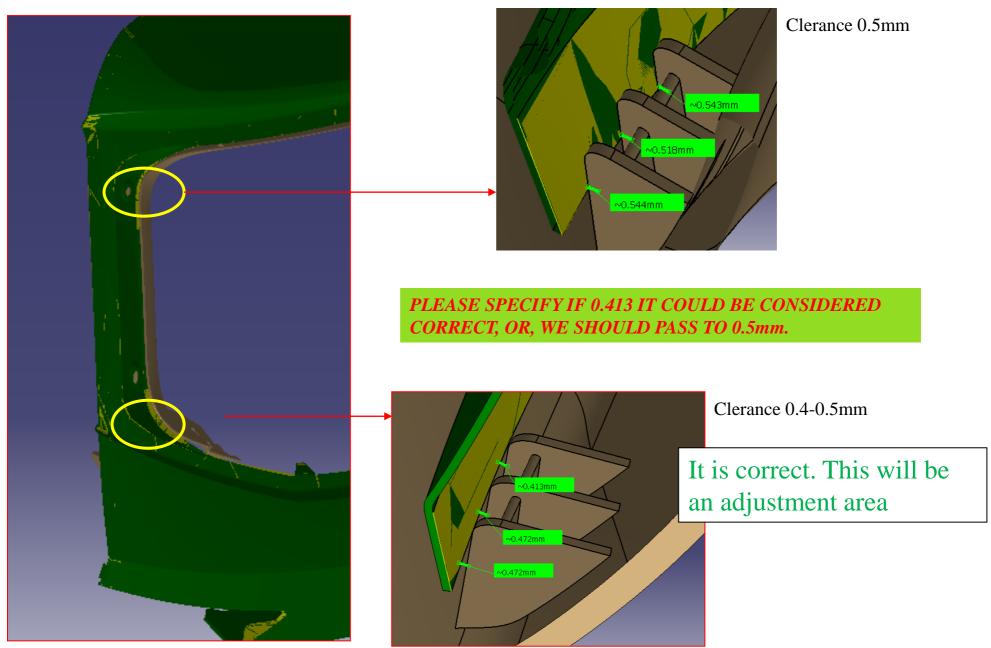
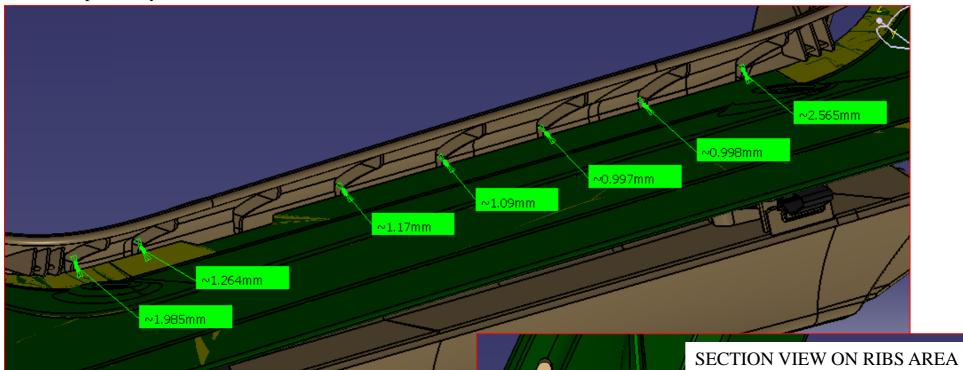
Side ribs proximity 1mm minimum.

PLEASE SPECIFY IF THE 1mm GAP IS GOOD ENOUGH (RIB HIGH 3mm).

Please, get a minimum gap of 1,5mm.

PLEASE SPECIFY IF THE 1.5mm GAP IS GOOD ENOUGH.

o.k.

GAP 1.5 mm

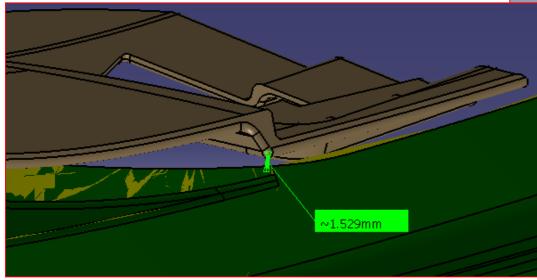
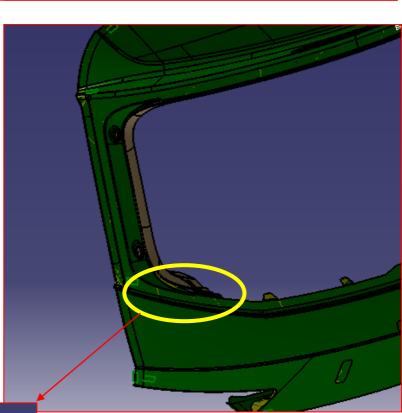
PLEASE SPECIFY IF THE 3 mm GAP IS GOOD ENOUGH.

o.k.

3mm gap between B face and EOP of sheet metal part on the upper ligne.
