File name: X23-575_867_603____GEO_EN__005____RVTO_MARCO_LUNETA__B-GUSS_KW29___170714_SE376_ACC_141020_003.CATPart

ACC REODUCT-ENGINEERING Proximity report

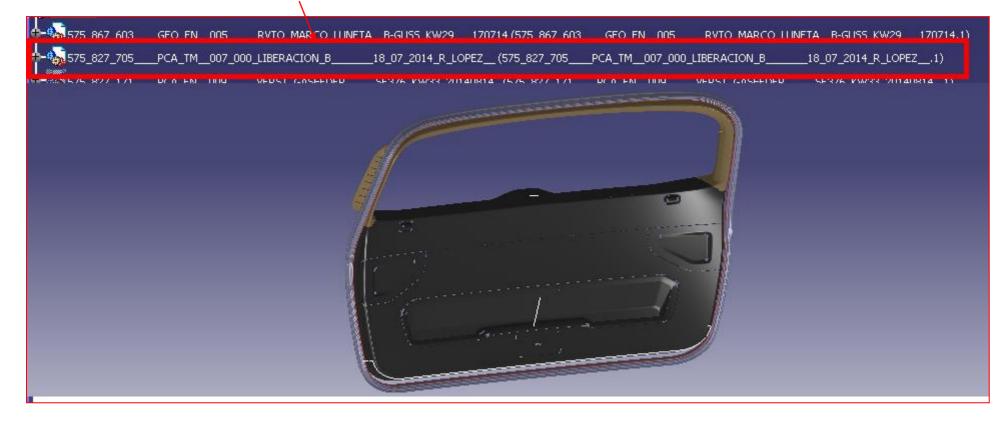
Remark: Possible issue for style surfaces.

Apearence - not constant gap in this area

I will inform Seat in order to get a feedback
